Manhole Inspection Summary

Manhole # S13EE1017MH

Location Address: **2820 QUANTICO AVE**

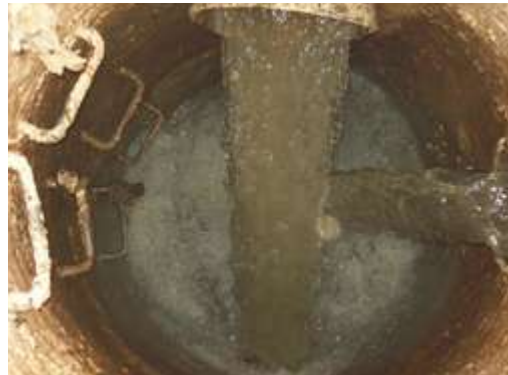
Top View

Comments **LOCATED BY REI ON 2-5-09. OPENED USING 16LB MAUL TO CRACK SEAL. APPEARS TO HAVE BEEN LINED. HEAVY FLOW COMING INTO LINE FROM 3 DIRECTIONS PREVENTED TAKING APROPRIATE PICTURES AS EXPECTED OF IN INSPECTION. HEAVY FLOW ALSO PREVENTED TAKING ACCURATE MEASUREM**

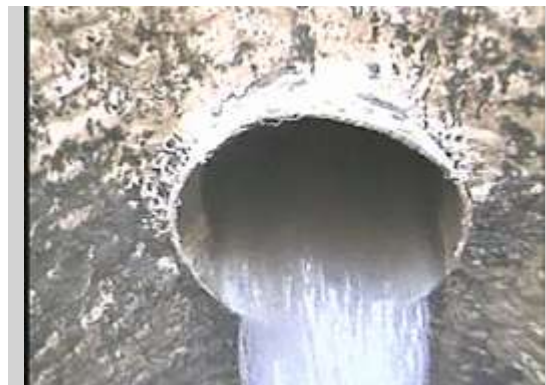
Drop In @ 6 O'Clock

IMPOSSIBLE TO CAPTURE PIPE
CONNECTION PICTURE WITH POLE
CAMERA DUE TO VELOCITY OF FLOW
